08.11.2005

Damage to Rudderblades

(Capt. Dipl.-Ing. U. Kreitz, Verein Hanseatischer Transportversicherer e.V.)

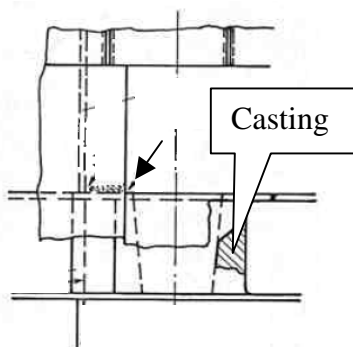
The picture shows that the construction of a rudder horn for a semi balanced rudder requires a distinctive geometrical notch (10).

The geometrical notch (change in rigidity) is located at the intersection of the horizontal and vertical contour line at the upper end of the conical coupling (casting) for the pintle.

The highest dynamical bending loads will occur at this intersection. To avoid any notch effect at this location it is necessary to construct a “soft” transition for occurring stresses.

In the area of this notch, respectively in the immediate vicinity of it, on many vessels damage due to cracks did occur. The starting point of these cracks is characterised by the geometrical notch in connection with cyclical strong dynamical loads in this section of the rudder blade.

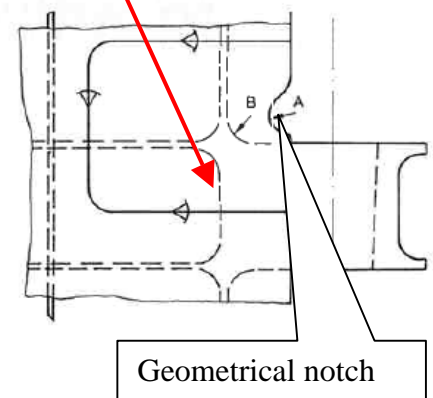
Another starting point for cracks may be found above the pintle bearing in the area of the access opening.

Because of given reason the butt welds of the access opening on port and starboard side have to be tested by ultrasonic for freedom from error

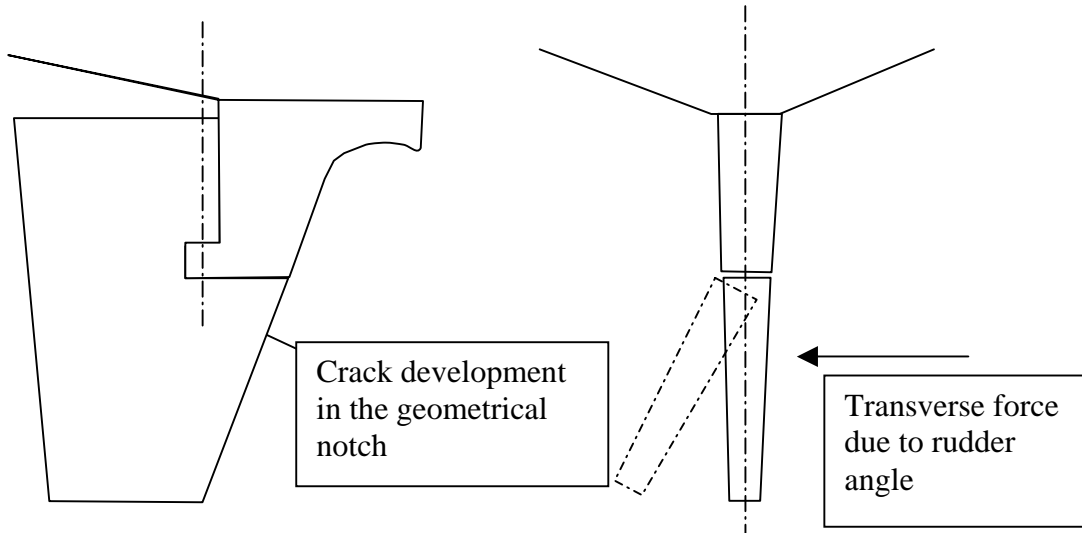
As a consequence of such cracks rudder blades broke below the rudder horn or were even lost totally.

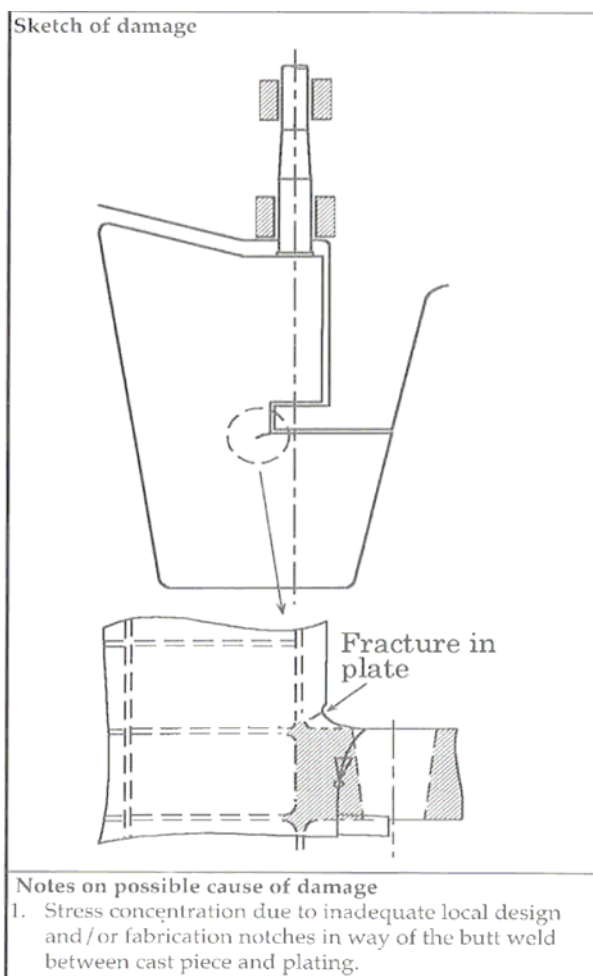
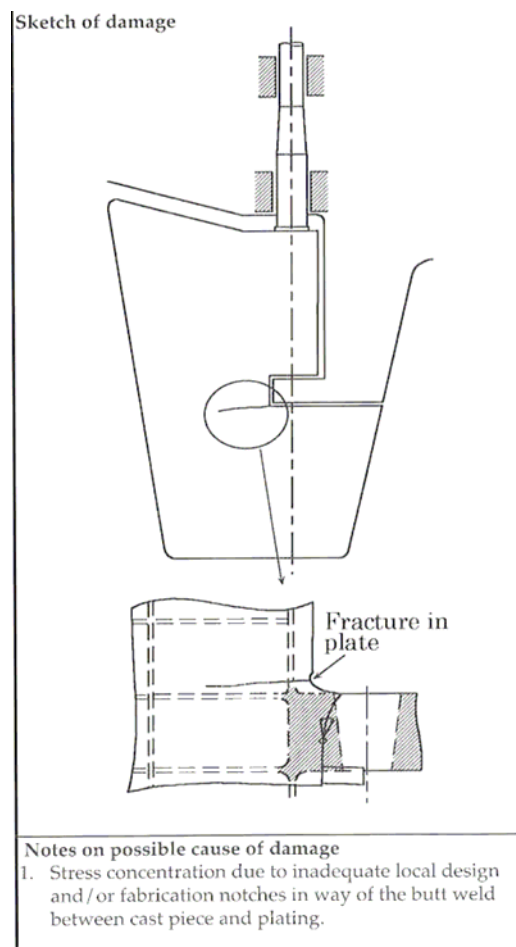
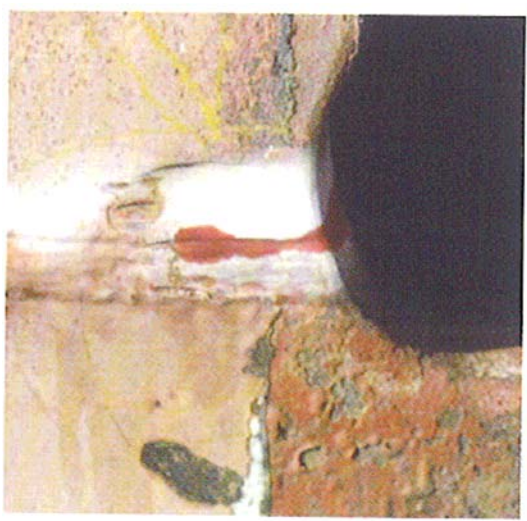
Sketch of damage

Examples for cracks in the vicinity of the geometrical notch and its causes:

Fracture in plate

Fracture B; In weld

Fracture A; In plating

1. Inadequate design for stress concentration in way of pintle bearing (Fracture A).
2. Imperfection in welding seam (Fracture B).

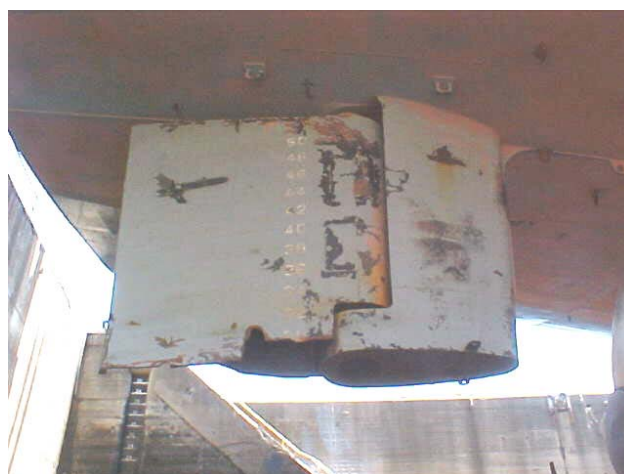
Caused by a crack in the geometrical notch the lower section of a rudder has been lost at sea.

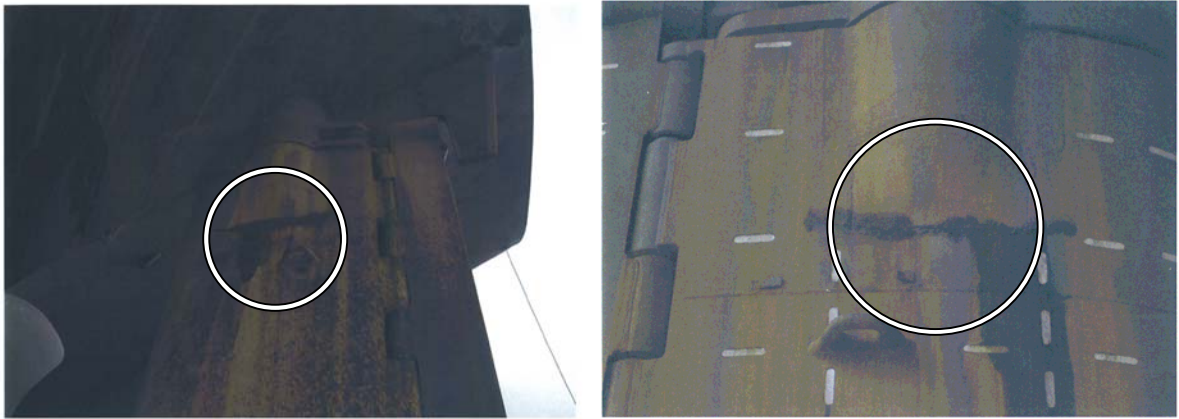
Cracks will occur on Spade Rudders (e.g. Becker Rudder, Hinze Ruder or Barkemeyer Rudder) just below the conical coupling. The highest bending loads will occur in this area. These cracks may as well lead to the loss a the rudder.

Typical cracks below the conical coupling

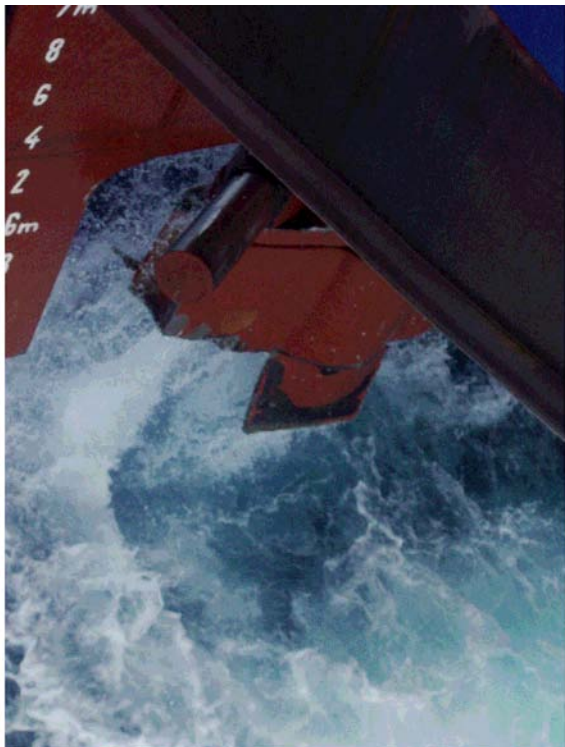
Loss of a Becker Rudder

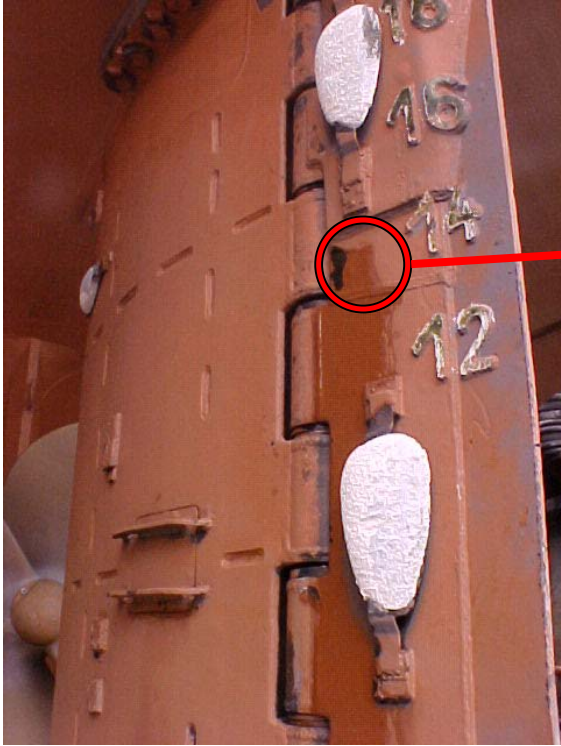
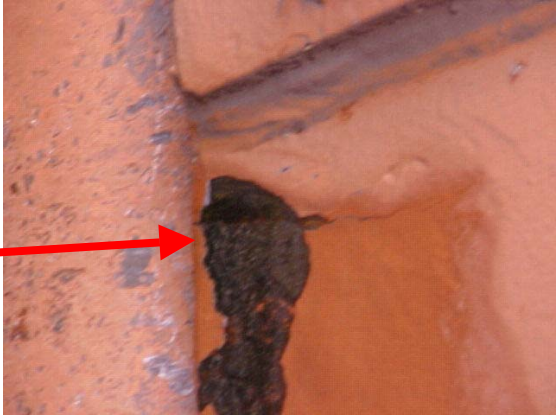
Cracks will not occur in the rudder blades only but as well in the additional blades of special rudders.

Crack in an additional rudder blade

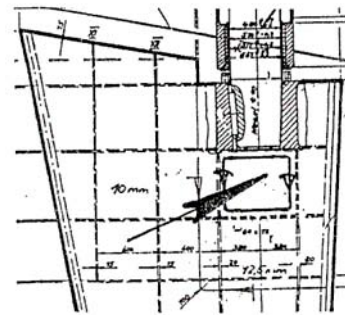
The cause for this type of damage often is superficial and negligent fitting work. The owners representative should carefully check any and all works carried out to the rudder at all times.

- at each dry-docking
- at each refitting of the assembly plate of the access opening
