**Bottom repairs on single hatch ships or on ships with relatively long hatches**  
Capt. Dipl.-Ing. Uwe Kreitz

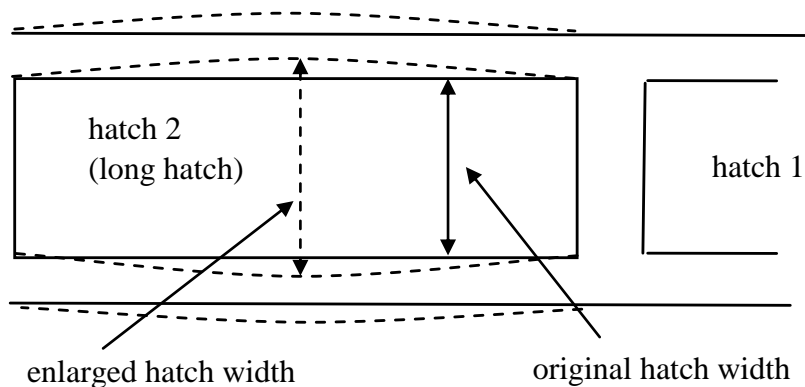
In regard to bottom repairs on ships with one hatch or with relatively long hatches, the ship's transversal structure may deform (gape) to such an extent that the hatch side coamings diverge (they are pulled outwards, so to speak.). Thus, the hatch opening expands the most in the about the middle of its length. We have witnessed gaping of 100 mm and even more.

gaping = enlarged hatch width – original hatch width

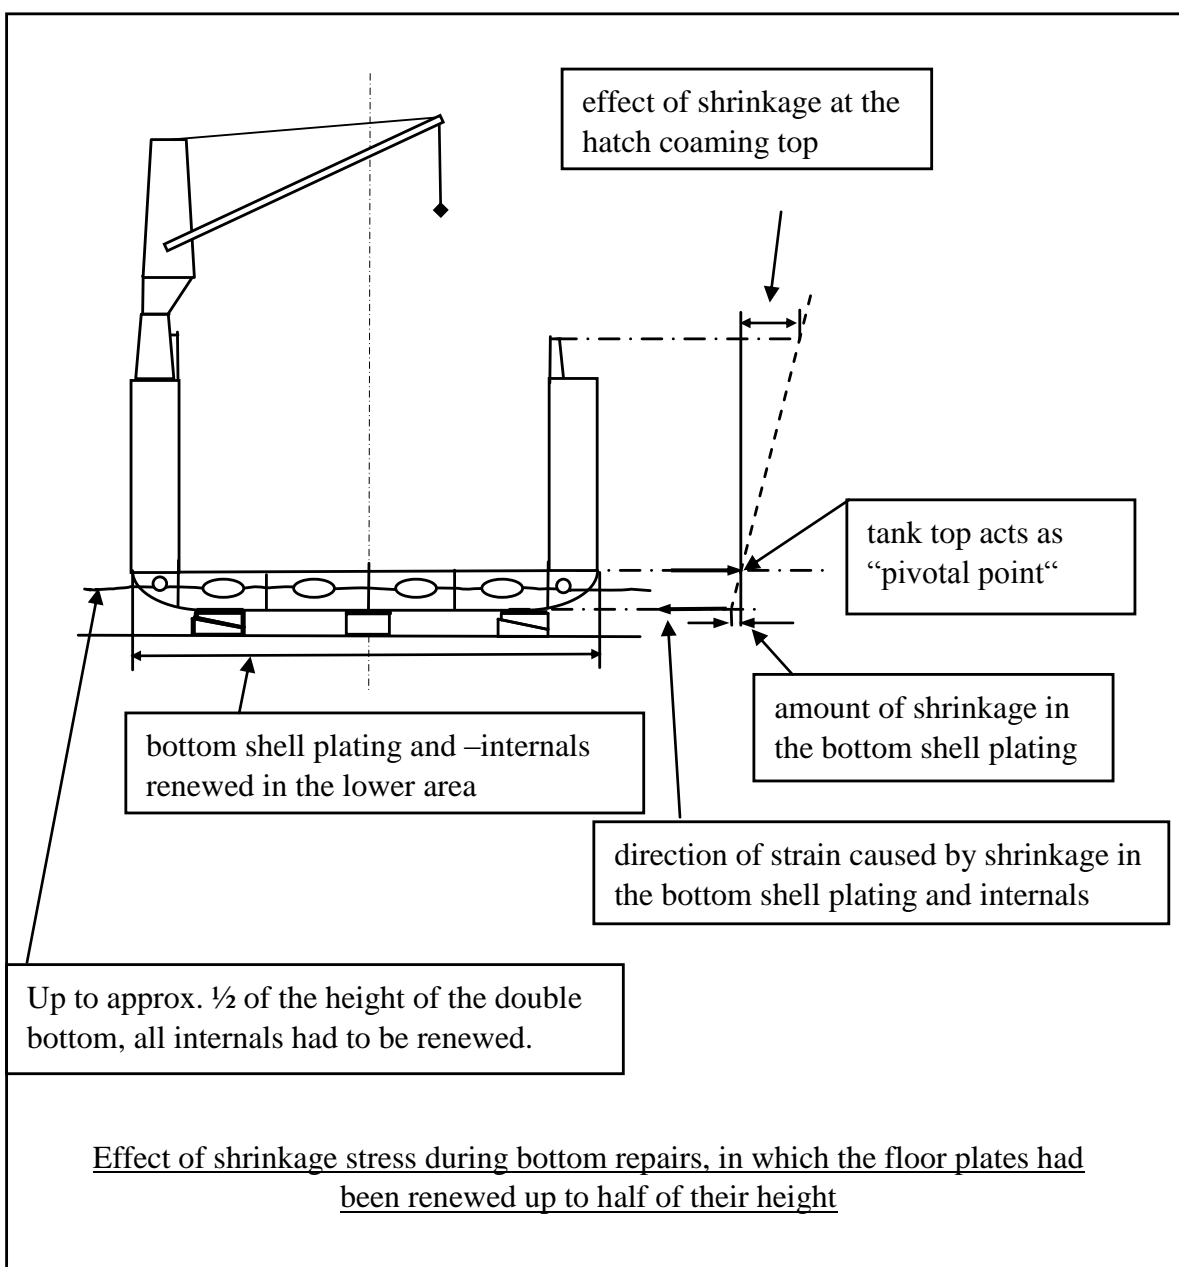
The previously mentioned sources of stress, particularly the shrinkage stress resulting from welding in the double bottom area, can cause contraction, reducing the ship's width in the bottom area. The resulting pull has its effect to the centre line of the ship. The fixed-point or, respectively, the "pivotal point" lies at the height of the tank top. Thus, the top of the hatch coaming moves outwards (gapes), i.e. diametrically to the direction of the force in the double

bottom structure. This is the source of the problems with the hatch covers mentioned at the beginning of this essay.

The width of the gaping is dependent on the distance between the tank top and the top of the hatch coaming.

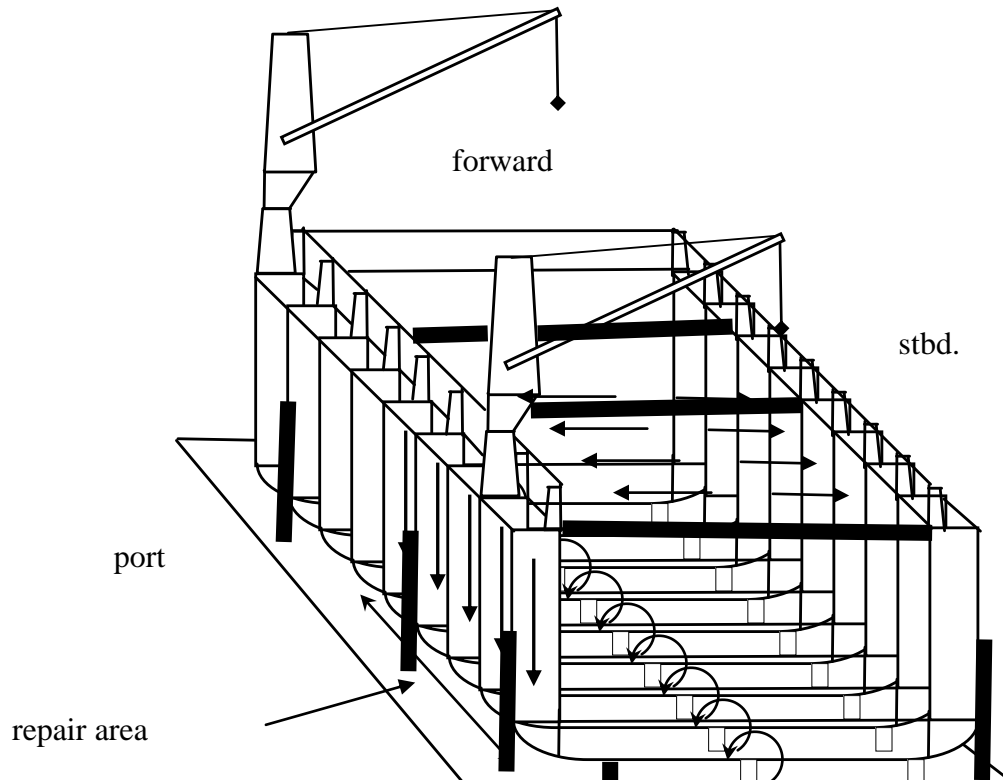
overall view in the dock

In way of the aft crane, the side blocks are removed locally (port side).  
 anti-clockwise torque force resulting in way of the keel blocks  
 vertical force resulting in way of the “side boxes”  
 horizontal force resulting in port and starboard direction

When performing extensive bottom repairs, not only transverse strong beams (possibly diagonal stiffeners, as well) are fitted into the hatch opening, but side supports are also fitted to the ship from the outside.
