Machinery claims - Lessons learned?

IUMI Conference 2013,
IPP Flash Presentation
London, 17th September 2013

VHT
Verein Hanseatischer
Transportversicherer e.V.

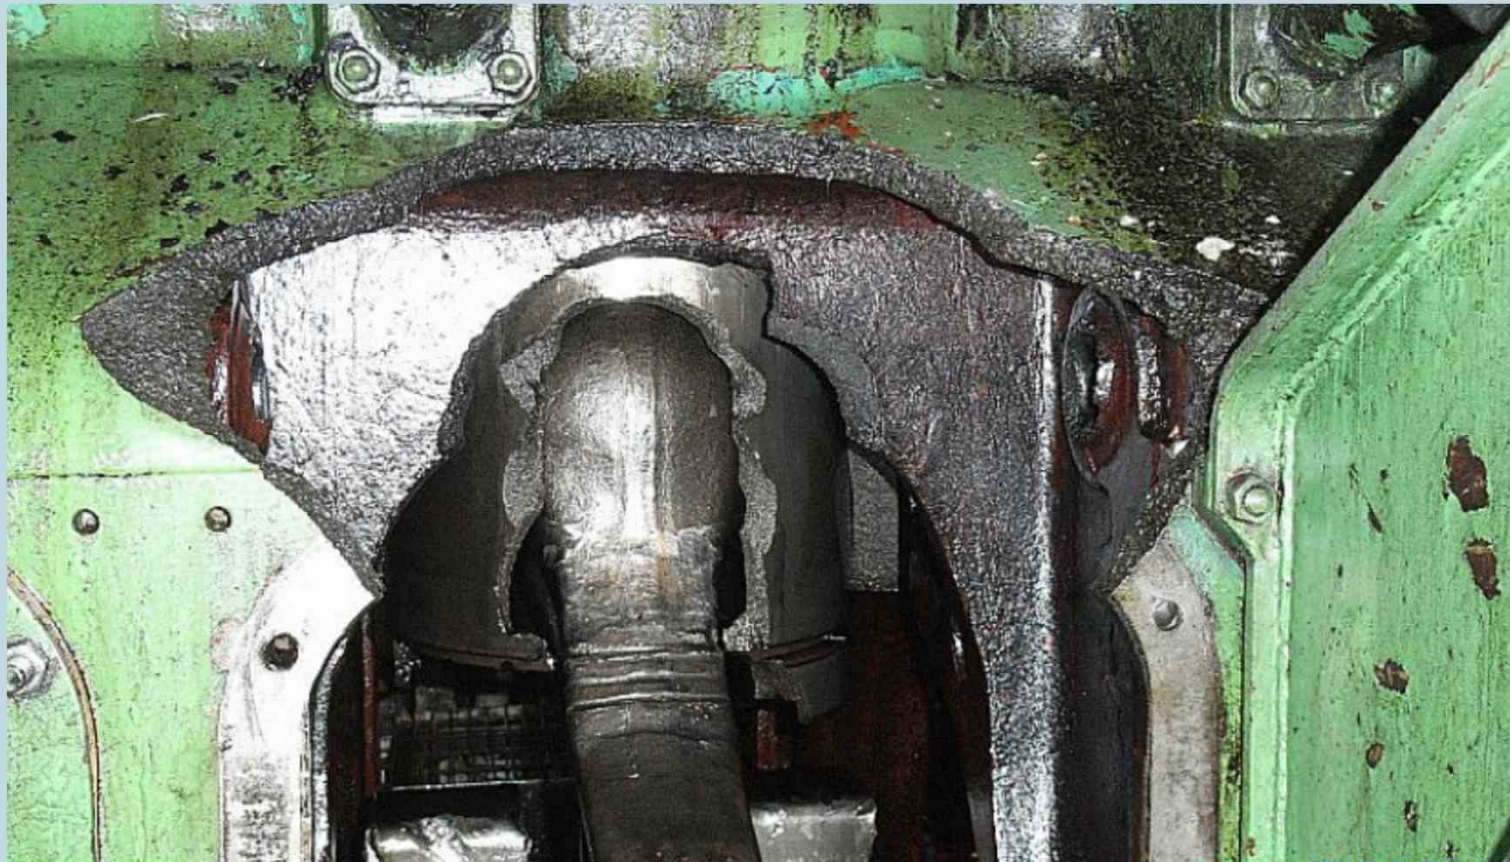
- VHT statistics suggest an increase in severity of machinery claims over past years

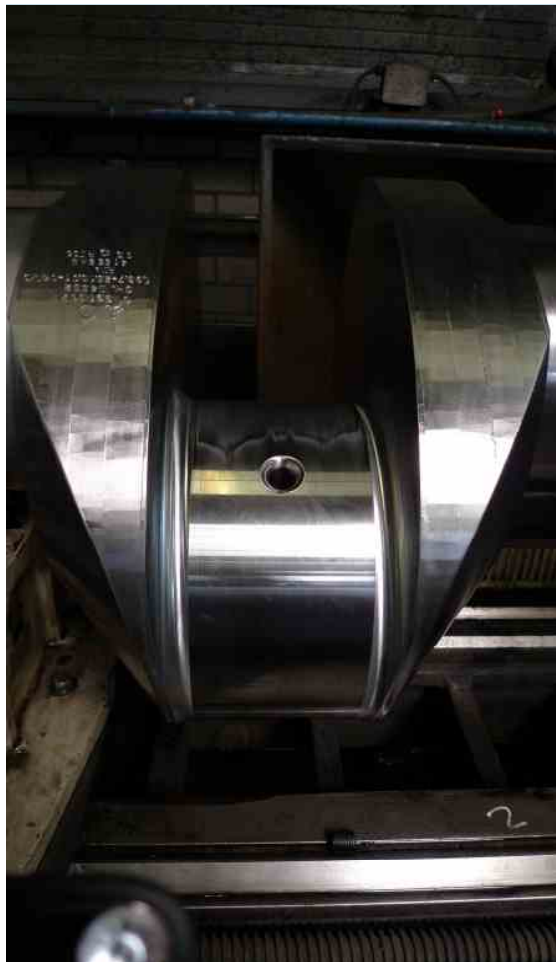
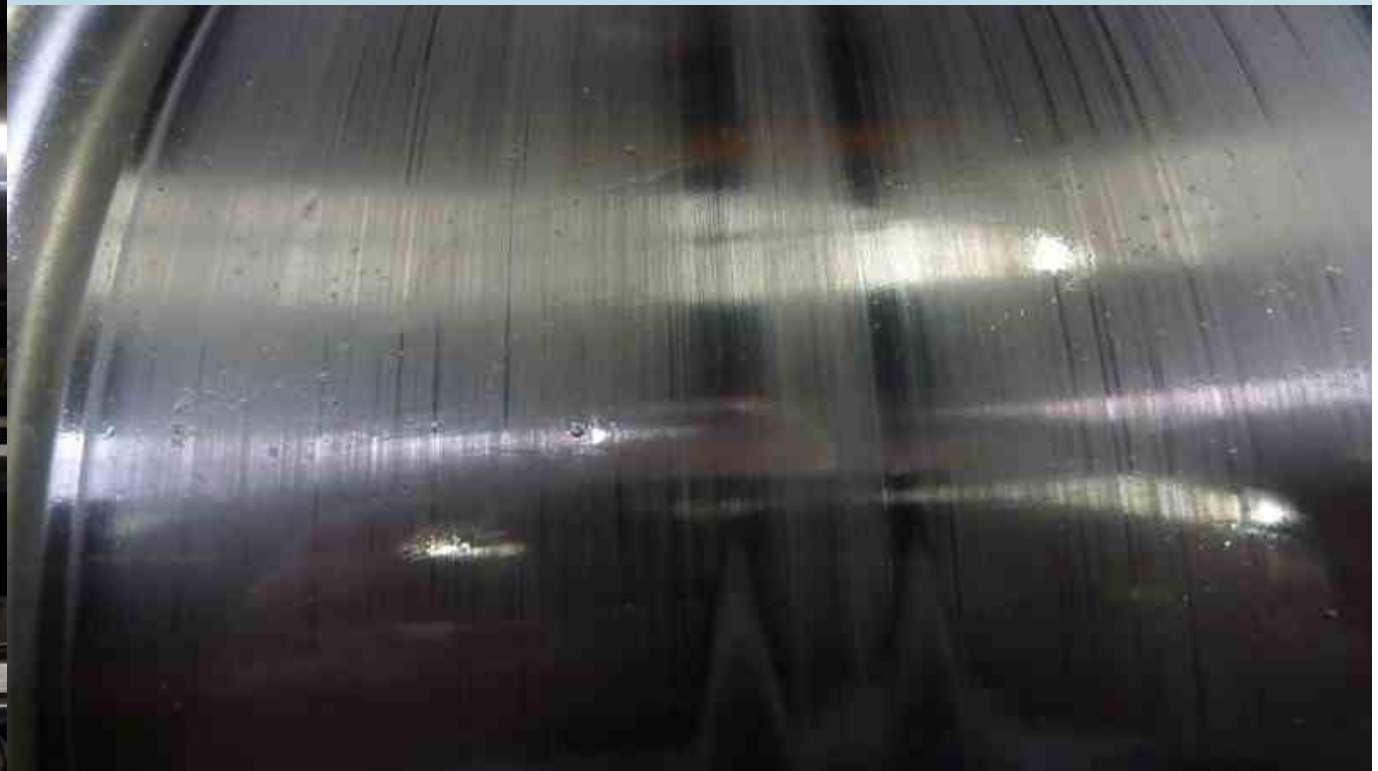
- Damage to crankpin bearings and main bearings on account of 17.5% water in lube oil

- Lesson learned: Water-in oil sensors were installed by owners
 - effective and early detection of water in lube oil
 - alarm enables the crew to prevent damage

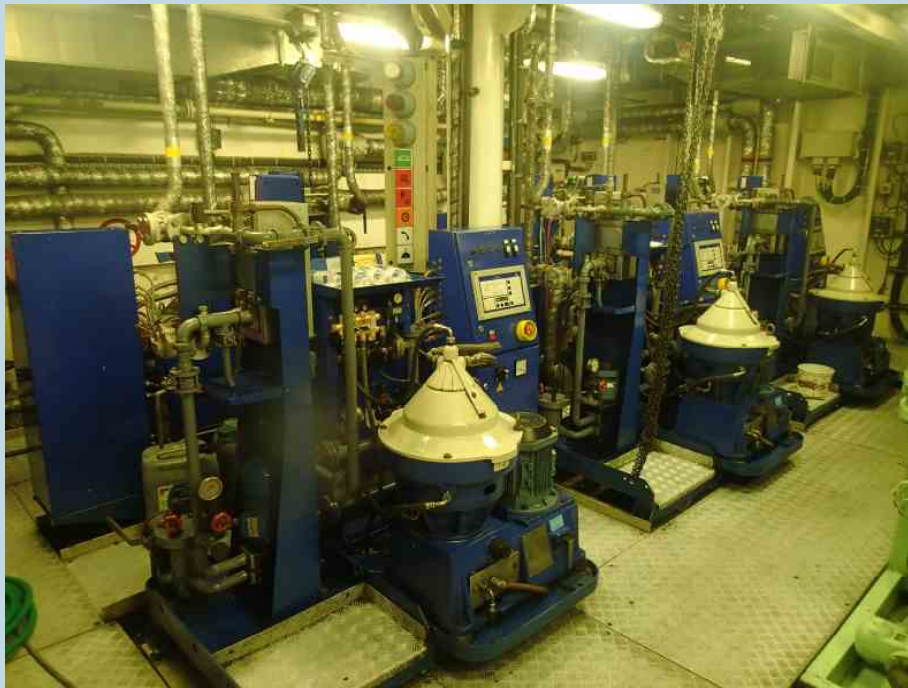
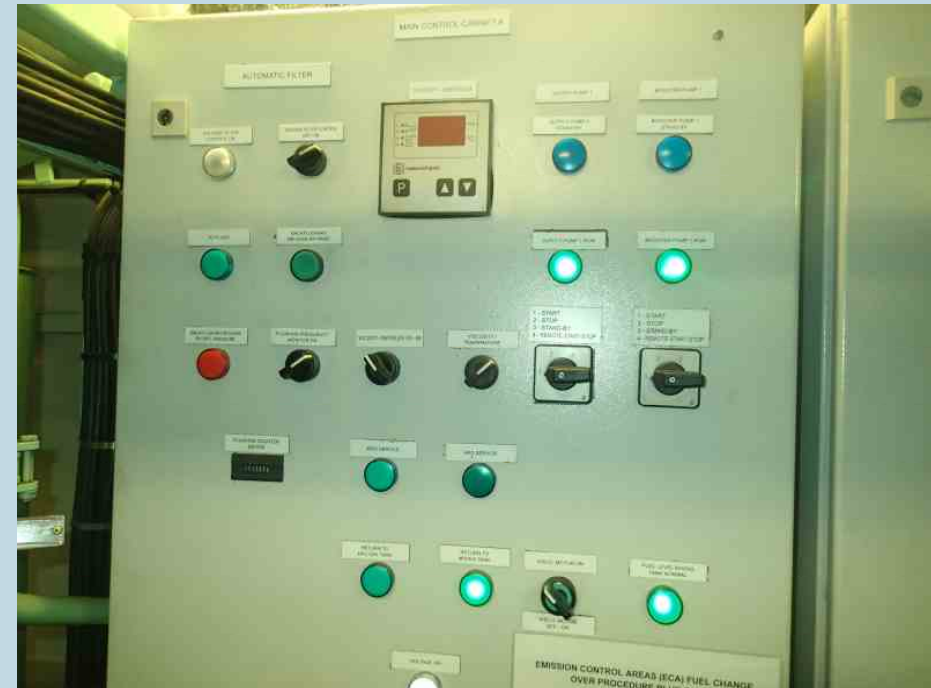
➤ Example: lack of proper purification and filtering

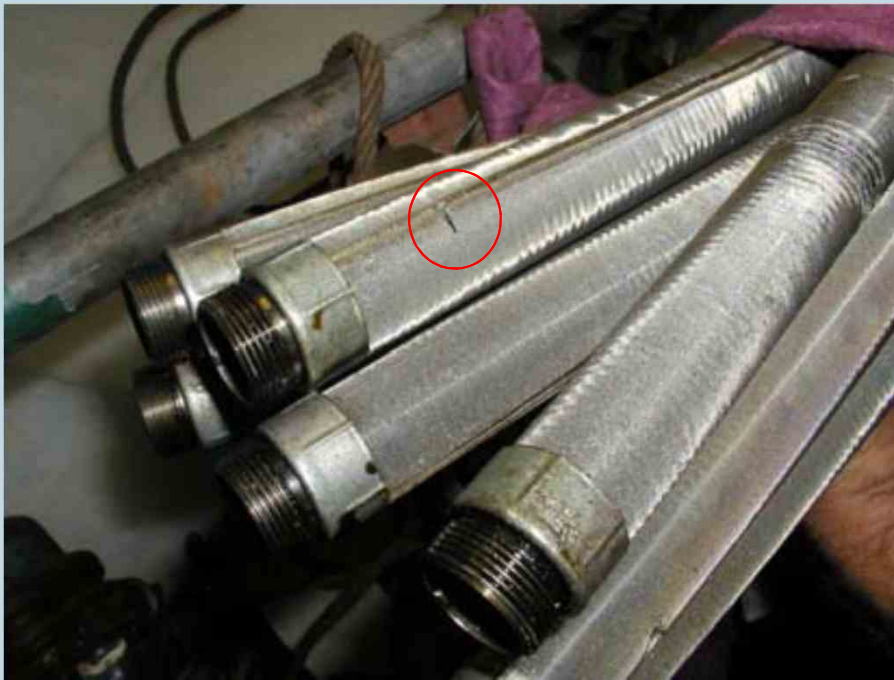
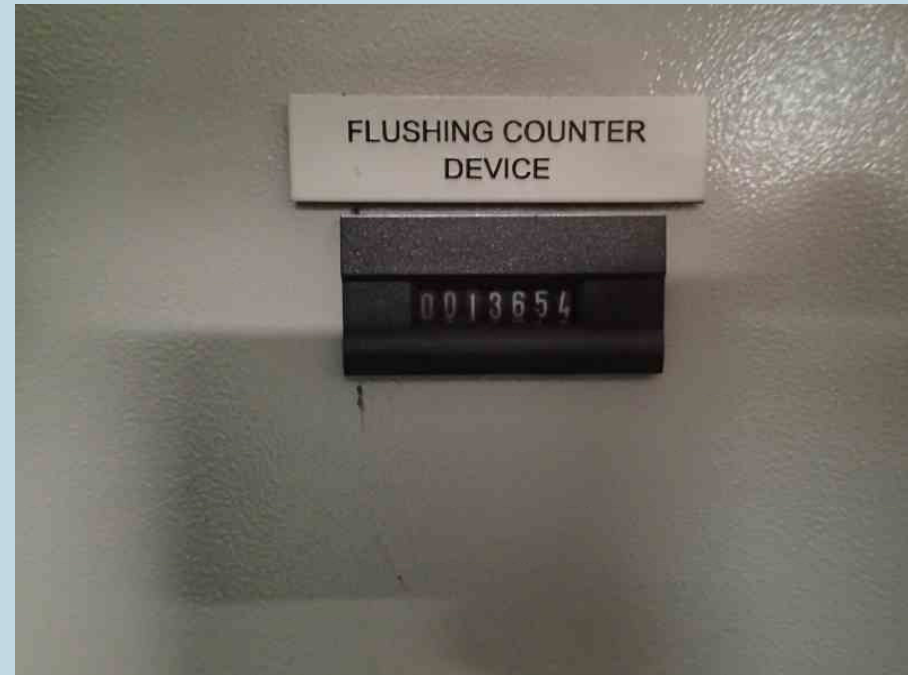
➤ Example: lack of purification and filtering

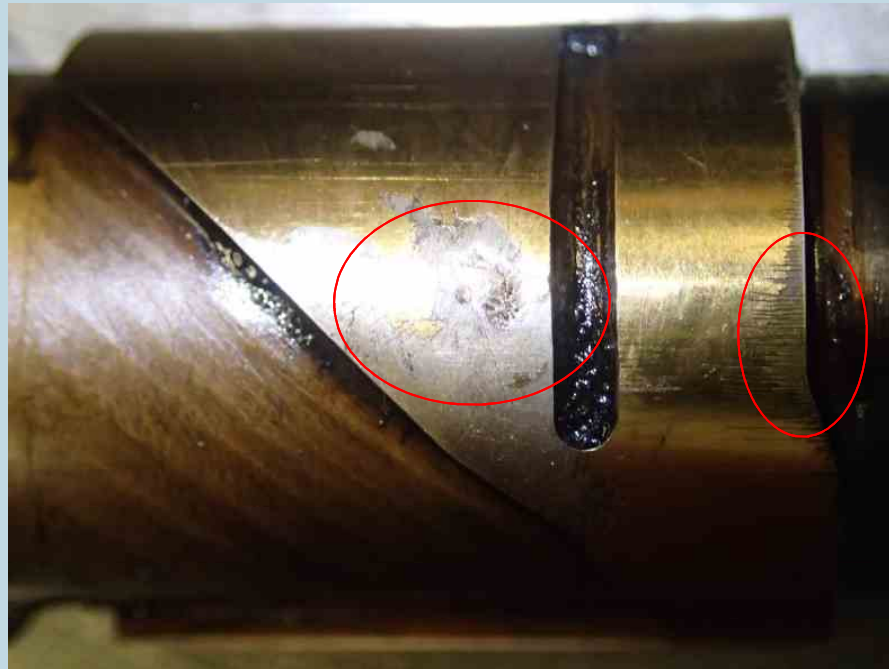
- Example: lack of purification and filtering
 - Result: severe damage to the fuel oil pumps and injection valves

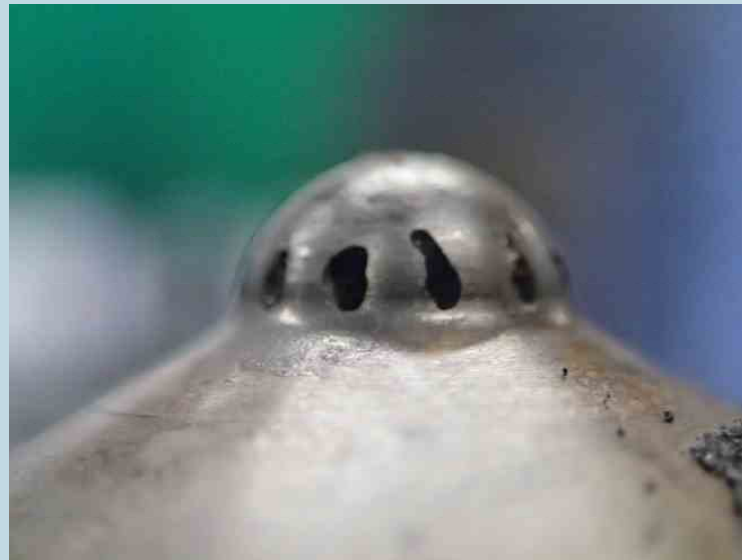
- Example: Unsuitable fuel with CATFINES
 - New fuel was not bunkered in separate tanks, but mixed with stock
 - Thus new fuel was used immediately upon departure from the bunker port
 - Result: The engine did not run for a long time...

- Analysis of bunker samples arrived one day later...

* PLEASE NOTE THAT THE RESULTS GAINED SHOW HIGH CATFINES / SEDIMENT / WATER / ASH, **THIS FUEL SHOULD NOT BE USED.** WE WOULD RECOMMEND A SECONDARY TANK SAMPLE BE SENT TO CONFIRM THE VALIDITY OF THESE RESULTS *
