## *Wire Damage on Ships' Cranes*

(Capt. Dipl.-Ing. U. Kreitz,)

The instance of damage that is being considered here concerns a

- **CASAR Powerplast** rope: Ø 58 mm, rotation-resistant, galvanised, lubricated, MBL 3.190kN for a ship's crane with **SWL 200 t**.

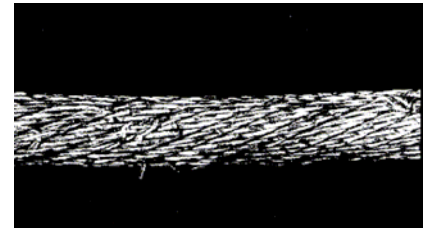
i) visible wire- and strand fractures corresponding to the register (DIN 15 020, section 2, page 3)  
e.g.  
at a length of 6 x rope's diameter; 15 visible wire fractures  
at a length of 30 x rope's diameter; 30 visible wire fractures

local concentration of wire fractures

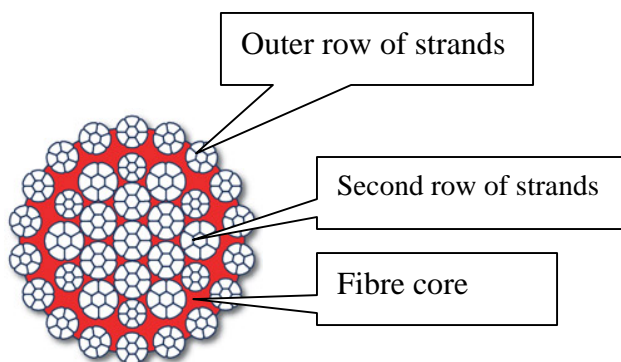
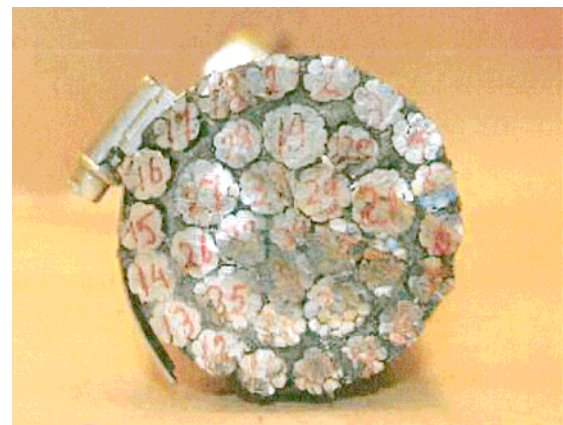
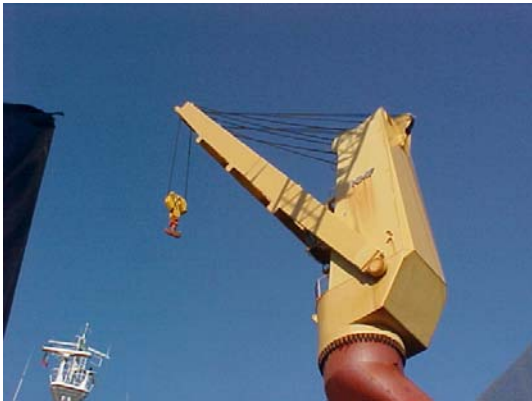
One of the most commonly used hoisting wires for ships' cranes is the **CASAR Powerplast**, a rotation-resistant hoisting wire made from compacted strands using a fibre core.

Design of the CASAR Powerplast wire rope (cross-section of the wire rope)

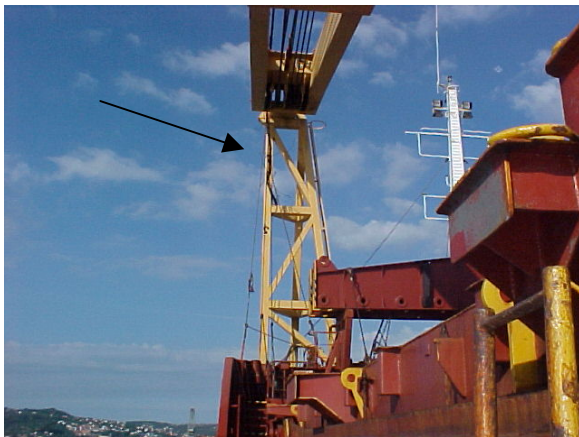
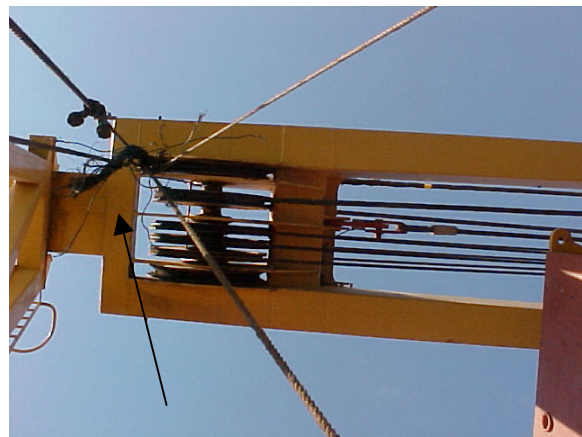
The hoisting wire on the jib's port side has broken between the deck and the resting crane jib.

Broken crane wire on the resting crane jib.

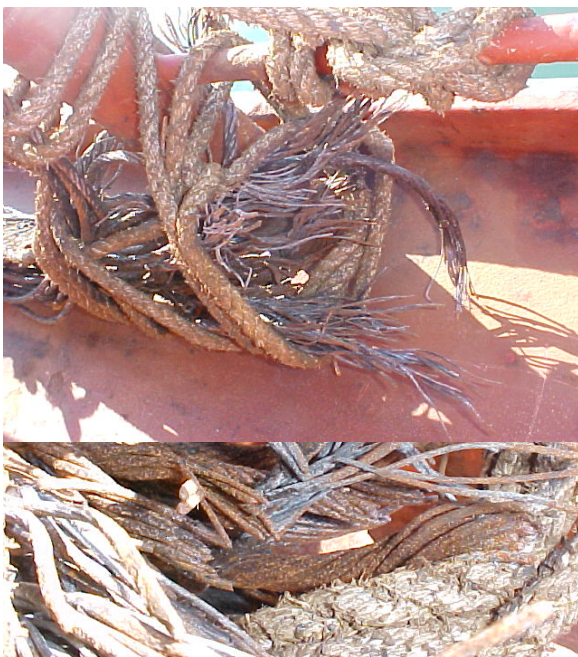
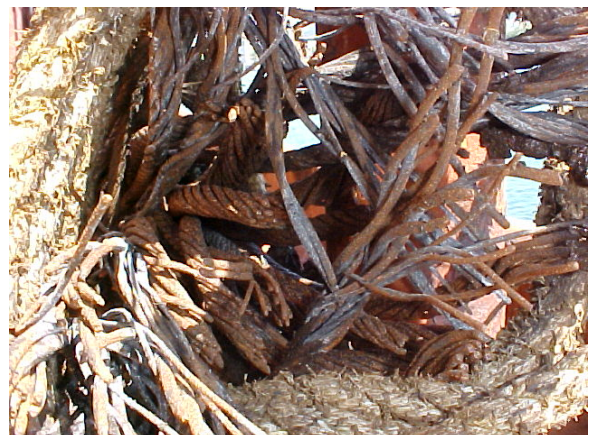
Pictures of the point of breakage on the wire rope.

It appears to be about a clear-cut rupture; that means that the broken strands occur within a short, locally-limited region on the wire rope. There are recognisable traces of corrosion existing on all wires. As a result of the corrosion, one can recognise, in part, heavily scarred and acute, broken wires.

According to the on-site findings, the area of damage on the wire rope is the area that leads under the crane jib through the bottom hook block. The damaged area (position of the rip) extends over 6 m long. There are, in several places, recognisable areas of corrosion under the lubricant layer.

The wire rope has had constant exposure (since 1997 = 8 years) to the sea (spray water and sea wash) particularly between the crane jib and the bottom hook block. The sea water can then eat at the wire rope's lubricant, and, respectively, wash it away and penetrate into the space between the individual wire strands and wires. In theory, when the wire is re-greased after a sea voyage, the lubricant does not penetrate deeply enough into the individual wire strands and wires, and it also does not repel the remainder of the sea water. Therefore, corrosion originating from within the wire rope may occur.

In addition, there is also the fact that wires in the jib's stow position (the bottom hook block is firmly tight) are exposed to particular stress that comes from the movement of the ship in heavy sea conditions. These refer to intermittent loads from the vibration of the jib ("nicking" of the jib), which lead to prematurely accelerated fatigue.

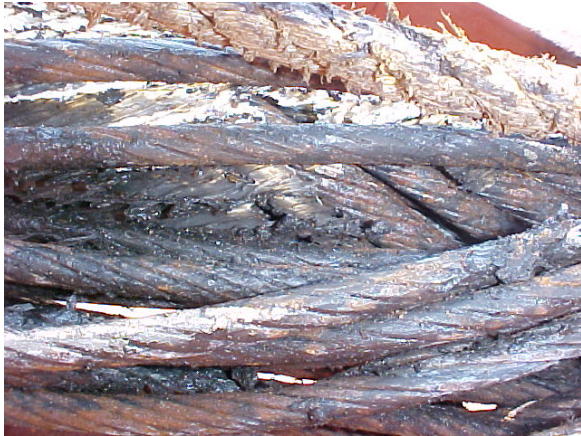
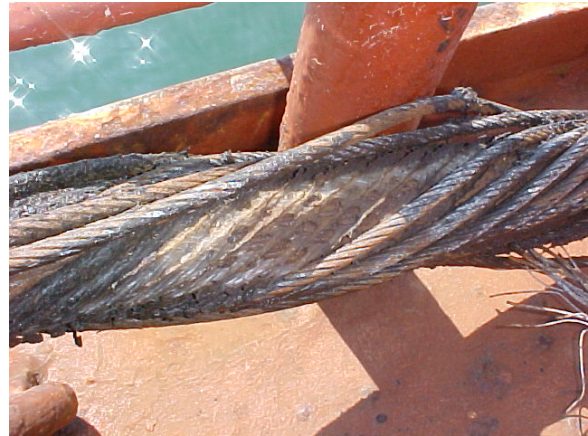
Detached wire rope structures with a perforated fibre core and corrosion on the wire strands.

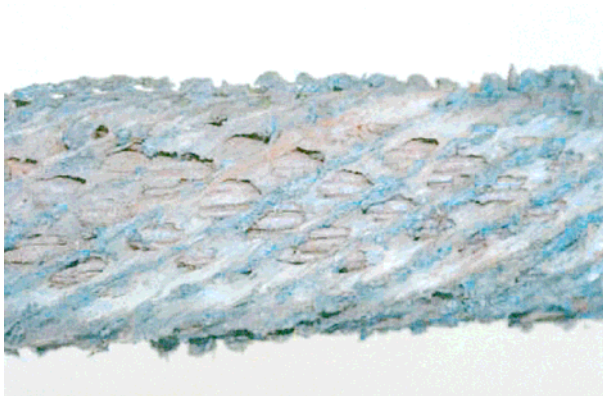
Outer row of the wire strands have been removed for the purpose of examination:

Finding: Heavily perforated fibre core. The perforation of the fibre core could have occurred through wear and tear as a result of internal rope friction.

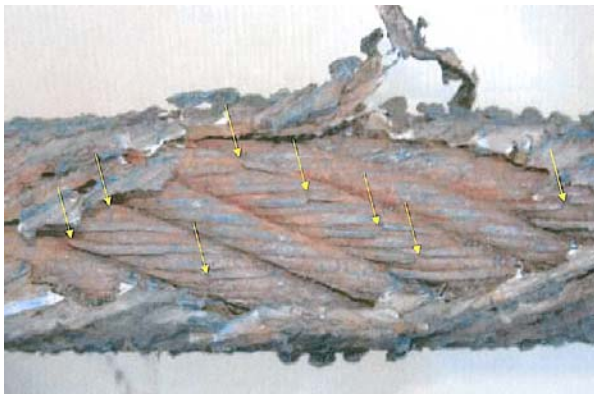
Outer row of the wire strands have been removed for the purpose of examination:

Finding: A steel core with considerable traces of corrosion. There is no recognisable lubricant present.

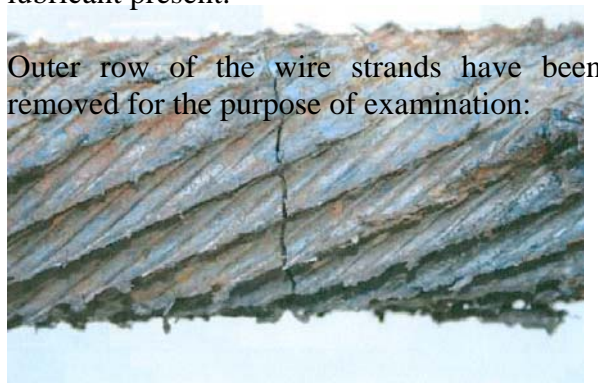
Finding: A transverse fracture in the plastic layer. Such a fracture could only have occurred as a consequence of the sudden impact on or the overstress of the steel core of the wire rope at the breakage.

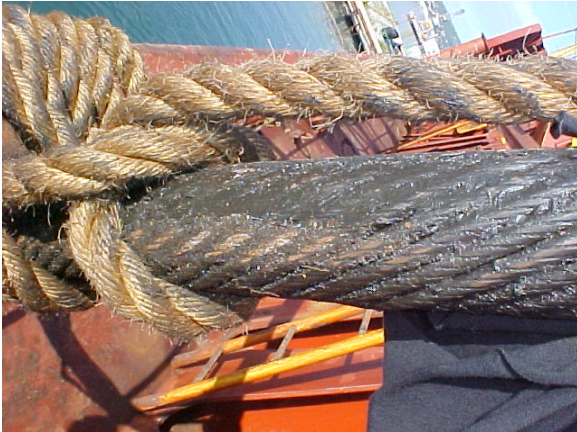
An intact rope structure with a relatively thick lubricant layer on its' surface.

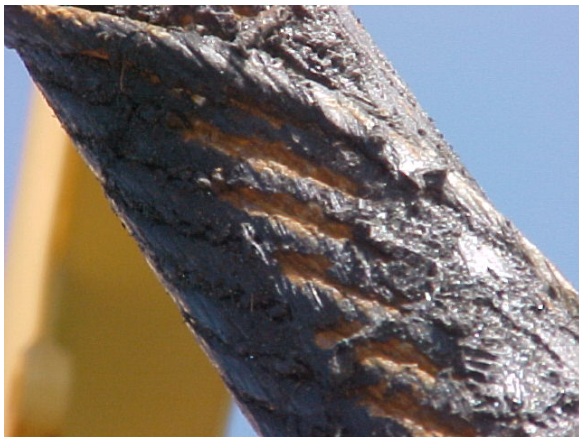
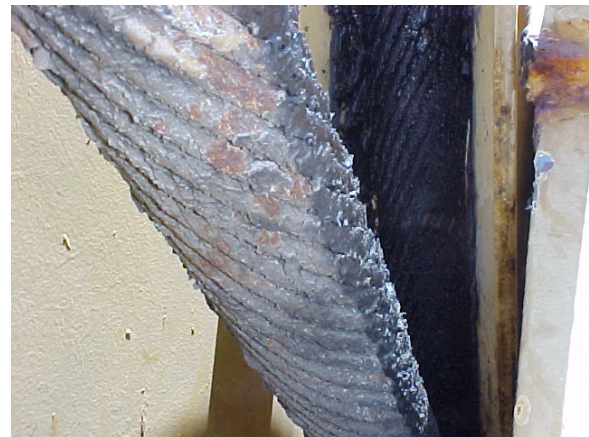
An intact surface of the wire rope is recognisable. The lubricant film is sporadically broken, and corrosion has built up on the surface.

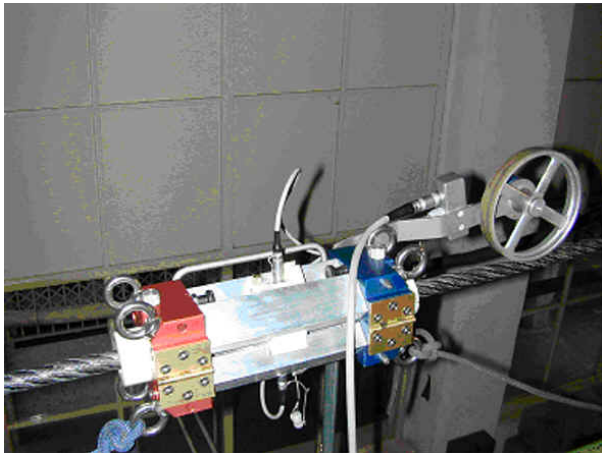
Electro-magnetic testing device CMRT 40

The electro-magnetic testing devices available on the market allow for, according to type of device, a gauge or a continuous list of local wire rope damage such as single wire fractures, strand fractures, brazing- and welding joints, or pitting corrosion. The ascertainment of the

alteration of a cross-section resulting from corrosion and metallic reduction of a cross-section from wear and tear throughout the entire accessible wire rope length is likewise possible.
