08.11.2005

Damage to Rudderblades

(Capt. Dipl.-Ing. U. Kreitz, Verein Hanseatischer Transportversicherer e.V.)

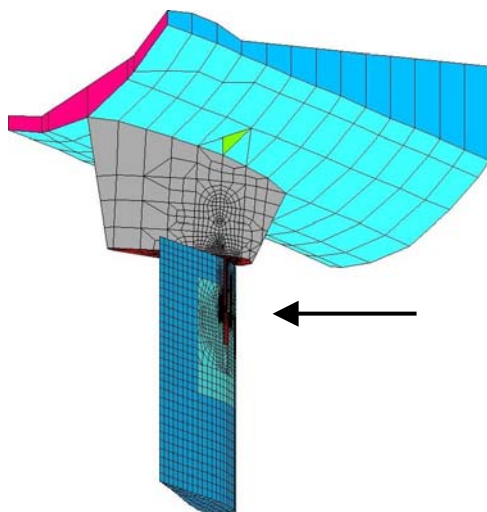
Forces occurring on the construction of a rudder can be shown by applying the method of "Finite-Elements"

A demanding „Finite Elements“ model was developed for the construction of a Spade Rudder. By using the model, reliable strength-calculations are possible.

Clearly it can be seen where the biggest forces do occur.

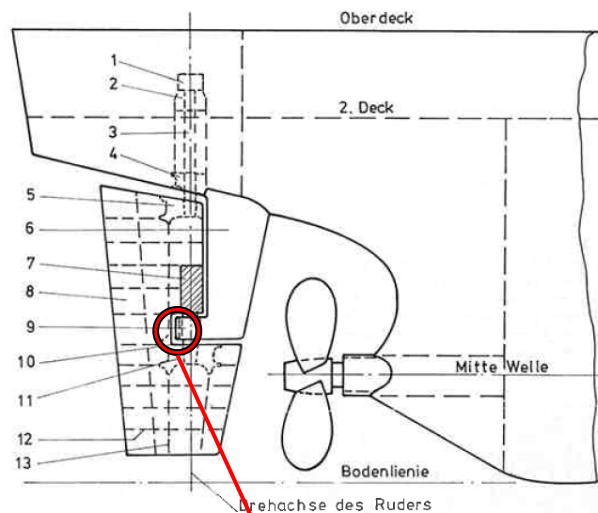
Semi balanced Rudder

- 1 – rudder engine
- 2 – upper journal bearing
- 3 – rudder shaft
- 4 – neck bearing
- 5 – rudder shaft conical coupling made of cast steel
- 6 – rudder horn
- 7 – access opening
- 8 – rudder blade
- 9 – pintle
- 10 – geometrical notch
- 11 – conical coupling for the pintle made of cast steel
- 12 – horizontal frame
- 13 – vertical frame

The picture shows that the construction of a rudder horn for a semi balanced rudder requires a distinctive geometrical notch (10).

The geometrical notch (change in rigidity) is located at the intersection of the horizontal and vertical contour line at the upper end of the conical coupling (casting) for the pintle.

The highest dynamical bending loads will occur at this intersection. To avoid any notch effect at this location it is necessary to construct a “soft” transition for occurring stresses.

In the area of this notch, respectively in the immediate vicinity of it, on many vessels damage due to cracks did occur. The starting point of these cracks is characterised by the geometrical notch in connection with cyclical strong dynamical loads in this section of the rudder blade.
