**Bottom repairs on single hatch ships or on ships with relatively long hatches**  
Capt. Dipl.-Ing. Uwe Kreitz

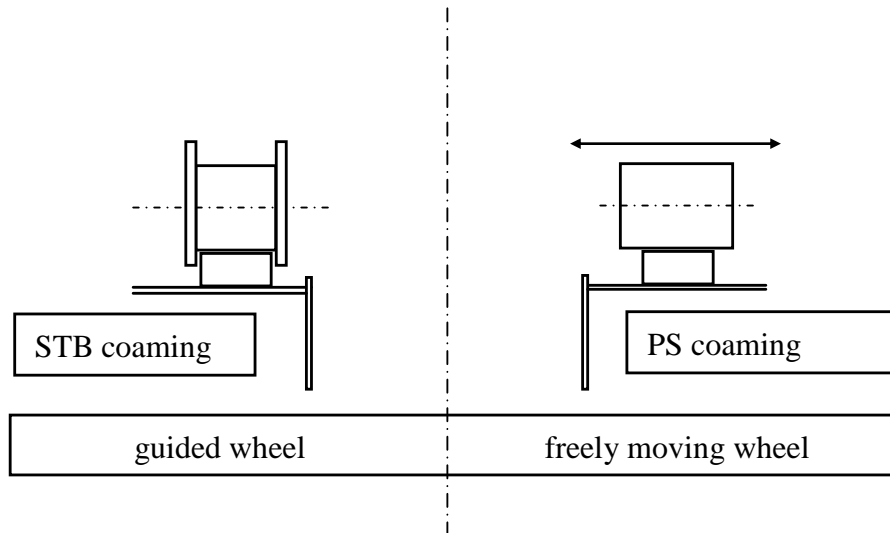
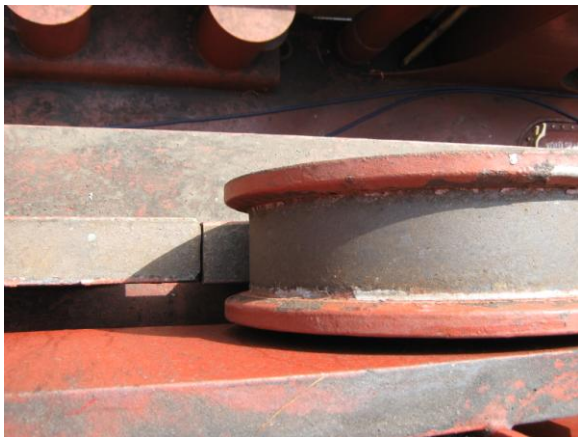
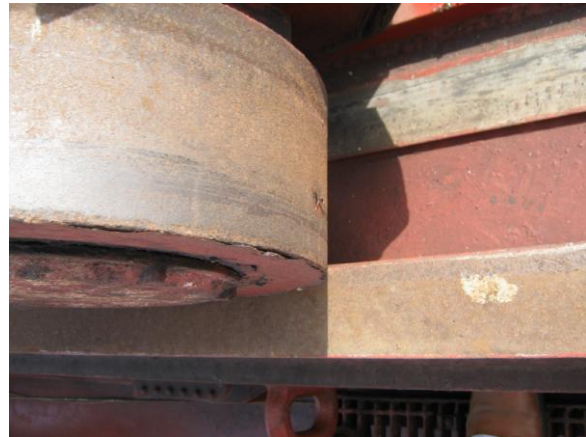
To ensure proper function of the hatch covers, the gaping of the longitudinal hatch coamings must be within permissible limits. The reason for the aforesaid is that the hatch cover wheels run on rectangular rails and have only little play on one side of the hatch because of the wheel's guide (does not apply to pontoon covers). Normally, the wheels are guided on one side of the hatch and may move freely on the other.

Independent of the wheel's design, every hatch cover manufacturer specifies a maximum permissible gaping (non-parallelism) of the rails. If this distance is exceeded, the hatch cover may e.g. get jammed during operation or (if worst comes to the worst) plunge into the cargo hold. A further consequence may be that the hatch cover in question does not seal the cargo hold water-tight any longer. It must be noted that the aforesaid applies to each type of hatch cover and influences the sea-worthiness of the ship.

If the ship's transversal structure has deformed beyond its permissible limits, the resulting gaping of the hatch coamings must be rectified. Normally, today, these repairs are performed directly on the hatch coaming. For this, the hatch coaming stays are detached from the deck, and the hatch side coamings are forced inwards hydraulically. The lower end of the hatch

coaming stays has to be renewed (at a height of at least 300 mm) and re-welded to the deck. As one can imagine, this is a costly repair.

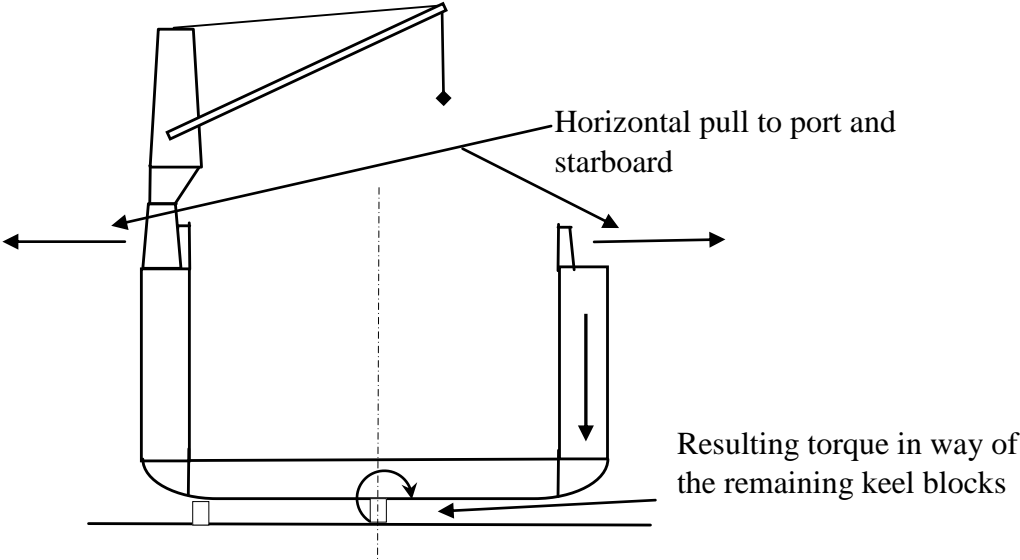
Ship in the dock, blocks removed on one side (starboard)

As soon as one or more supporting blocks is/are removed, the ship's body is no longer supported in this location. Because of the (ship's own) weight, the ship's structure will "sag" several millimetres in this area and will cause stress on the ship's body. Apart from that, the remaining blocks must hold additional weight. To minimise the "sagging", additional provisional supports are to be set up in the area surrounding the repair.

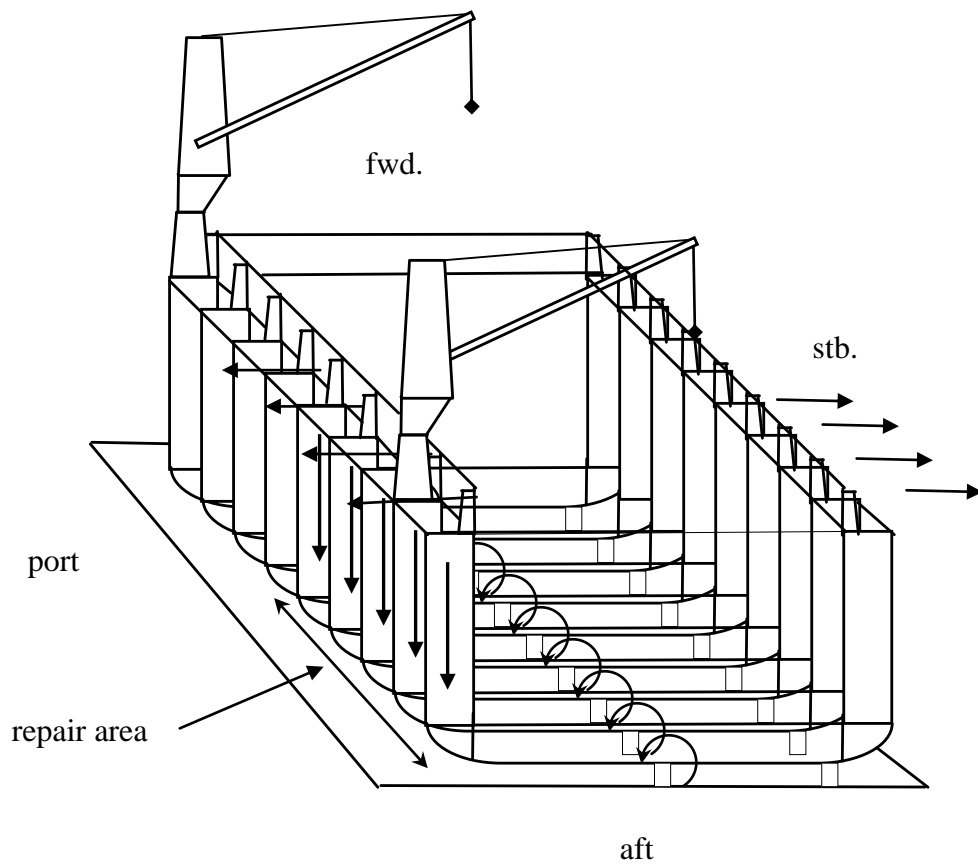
general view of the ship in dock

Cranes fitted on one side of the ship increase the weight force on the corresponding side (resulting from the crane's own weight).

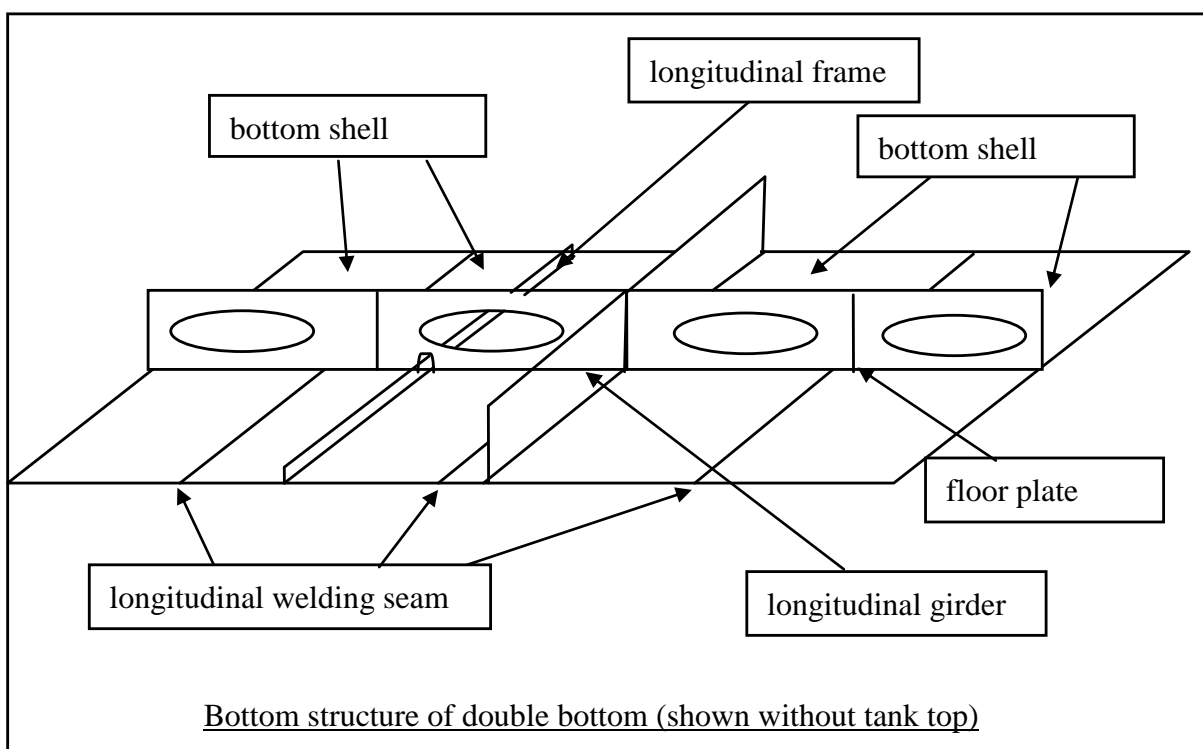
If the damaged plate areas including their longitudinal and transverse frames and stiffeners are cut out, a weakening of the bottom structure ensues. The weakening causes the ship's structure to deform because of the ship's own weight and, thus, causes additional stress on the ship's body. The amount of deformation is usually a few millimetres.

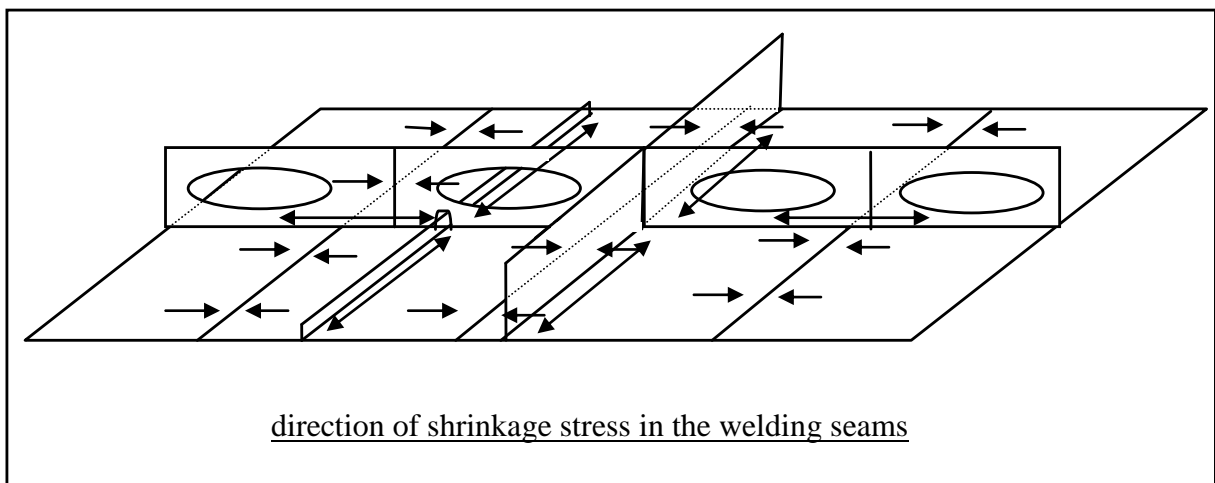
When new transverse structures (floor plates) are fitted by welding, shrinkage stress occurs in the horizontal and vertical welding seams, which contracts the floor plates by a few millimetres (pull). When the bottom shell and bilge plates are welded in, shrinkage stress occurs again in the longitudinal and transverse welding seams, which in turn generates pull to the ship's hull in the transverse direction. In the weld between the floor plates and the bottom shell plates as well as between longitudinal frames / -girders and bottom shell plates, shrinkage stress also occurs primarily in the transverse direction.

If the gap (clearance) between the steel plates to be welded together is too wide, a lot of welding material and heat must be applied in order to fill the gap and to properly weld the plates together. As a result, considerable shrinkage stress occurs while the welding is cooling off.

Gaps between the plates to be welded are to be kept as small as possible or as small as necessary. If a gap is too large, a lot of weld material and, thus, a lot of heat is introduced into the structural element, which, in turn, will cause significant shrinkage stress while cooling down.
